Manhole Inspection Summary

Manhole # S53M__008MH

Insp Date: **4/7/08 11:55 AM**

Location Address: **3004 mckay**

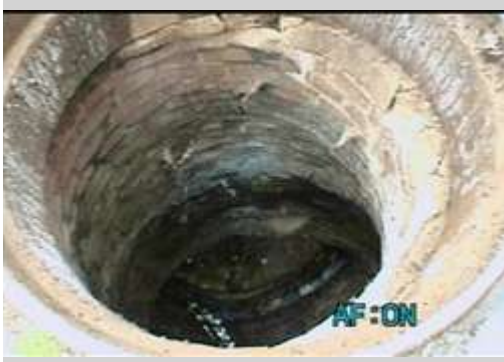
Defect 1

Condition: ☐ Sound ☐ Cracked ☐ Root Intrusion ☒ **Loose Brick** ☒ **Deteriorated**

Count: **5** Missing: **5** ☒ **Corroded**

steps missing/corroded; barrel loose bricks & deteriorated

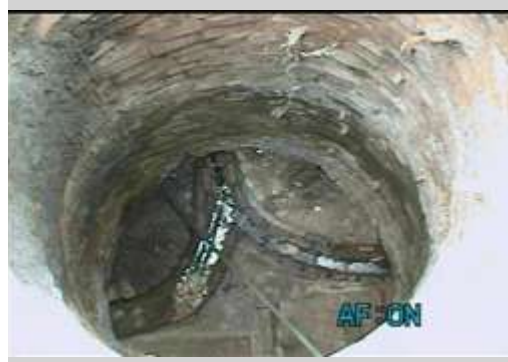
Defect 2

Infiltration: ☐ None ☐ Joint ☐ Cracks ☐ Mortar ☐ Roots ☒ **Wall**

☒ **Evidence Of Surcharge**

Depth: **3** (ft.) ☐ Active Surcharge Present

barrel infiltration wall, surcharge evidence

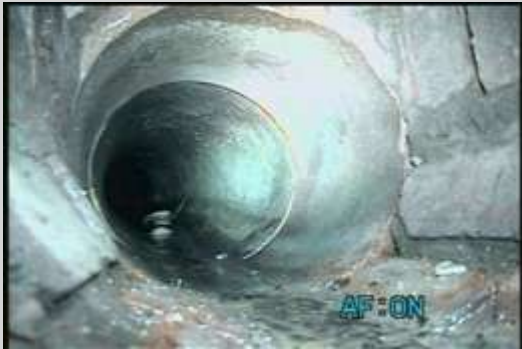
12 O'Clock Outflow

8 in. Circular Gravity Sewer
Pipe Out @ 12 O'Clock

Invert Depth: **8.90** (ft.) Flow Characteristics: **Slow**

Infiltration: **None** Pipe Seal Cond: **Unknown**

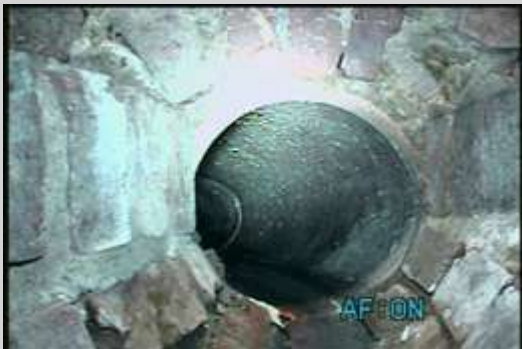
3 O'Clock Inflow

8 in. Circular Gravity Sewer
Pipe In @ 3 O'Clock

Invert Depth: **8.70** (ft.) Flow Characteristics: **Slow**

Infiltration: **None** Pipe Seal Cond: **Unknown**

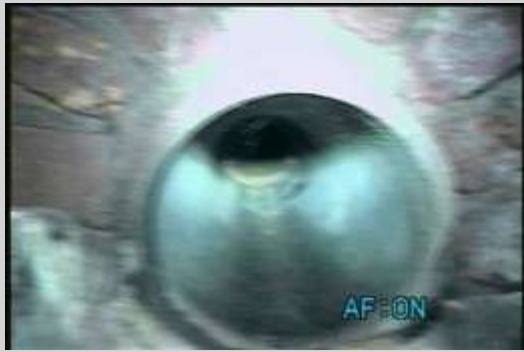
6 O'Clock Inflow

Invert Depth: **8.30** (ft.) Flow Characteristics: **None**

Infiltration: **None**

Connects To: **House connection / Service line**

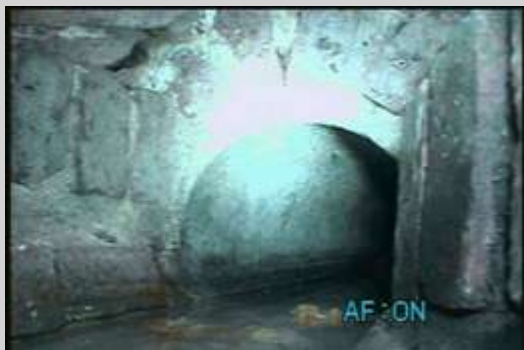
9 O'Clock Inflow

Invert Depth: **8.80** (ft.) Flow Characteristics: **Slow**

Infiltration: **None**
